UPPER PATUXENT RIVER WATERSHED RESTORATION ACTION STRATEGY (WRAS)

FORM 1 -- Catchment Information

UPPER PATUXENT RIVER WATERSHED RESTORATION ACTION STRATEGY (WRAS) FORM 2 -- Site Information

Site Name: 10th Street Cul de Sac Address: 10th Street, Bowie MD, 20720

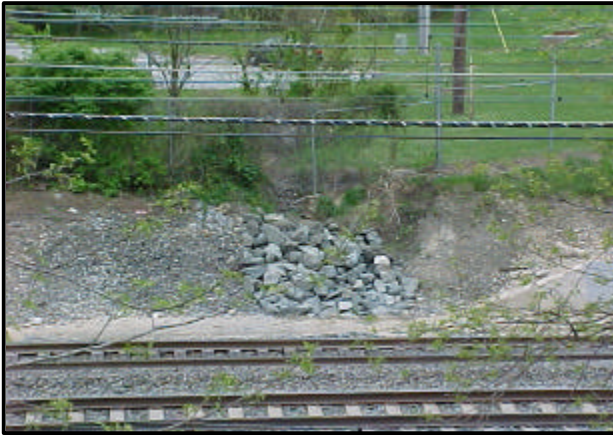
674

No. <u>674</u>	Description: <u>looking southeast to ditch outlet</u>
No. <u>675</u>	Description: <u>looking north to cul de sac</u>
No. <u>676</u>	Description: <u>looking north along ditch</u>
No. <u>677</u>	Description: <u>looking northeast across ditch</u>
No. <u>678</u>	Description: <u>looking southeast across cul de sac</u>
No. _____	Description: _____
No. _____	Description: _____
No. _____	Description: _____
No. _____	Description: _____
No. _____	Description: _____
